MEMORANDUM

Re: Post-TCRA Semi-Annual Inspection Report – October 2015

This document reports the results of the October 2015 inspection of the armored cap cover, fencing, and signage installed for the Time Critical Removal Action (TCRA) at the San Jacinto River Waste Pits Superfund Site (TCRA Site).

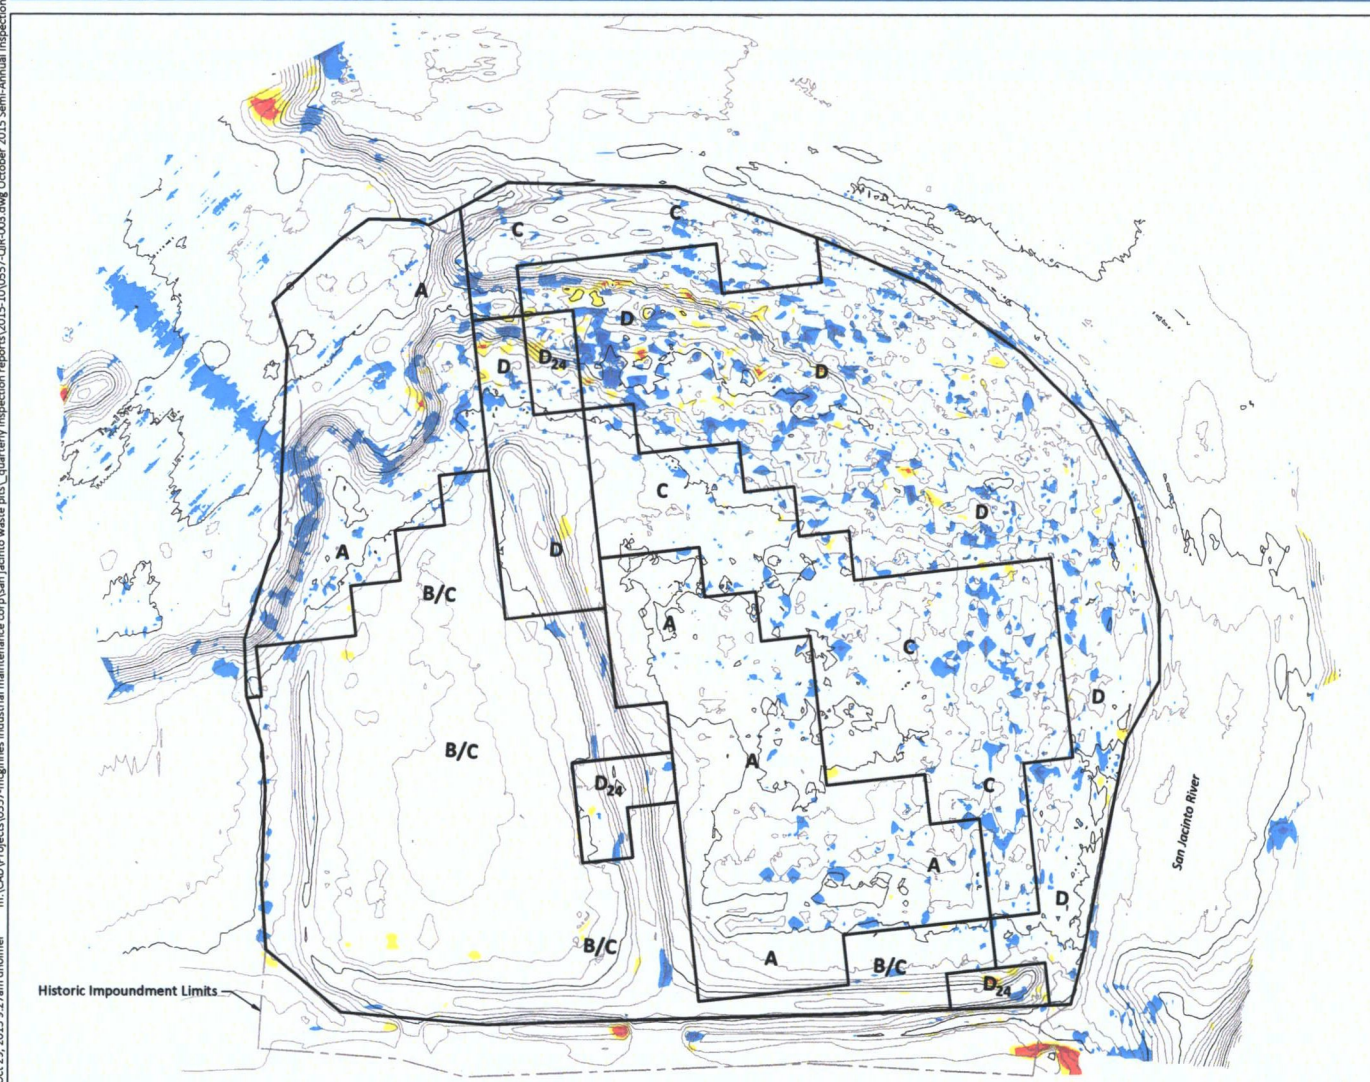
Figure 3
 October 2015 Semi-Annual Inspection
 Post TCRA Semi-Annual Inspection (October 2015)
 San Jacinto River Waste Pits Superfund Site

The survey data from the October 2015 inspection survey and the July 2015 surveys were compared to evaluate the differences in the top of the armored cap elevation. These differences are shaded and shown on Figure 3. The survey results indicate continued sedimentation/deposition on the surface of the armored cap in submerged areas.

Manual probing of armored cap thickness is required at areas identified by the topographic or bathymetric surveys as more than 6 inches lower in elevation than during the prior survey over contiguous areas of 30 feet by 30 feet. When the October 2015 and July 2015 surveys were compared, the results indicated that there were no areas that met the manual probing requirement. Therefore, no probing was conducted as part of the October 2015 inspection.

The small areas identified as increases and decreases in elevation can be attributed to the horizontal and vertical limitations of the survey, minor shifts in track line location from the baseline survey, and elevation data recorded in the crevices between rock surfaces or atop shellfish growth. The potential for these types of variations between the two datasets to exist was confirmed by the surveyor after reviewing the data collected during this inspection.

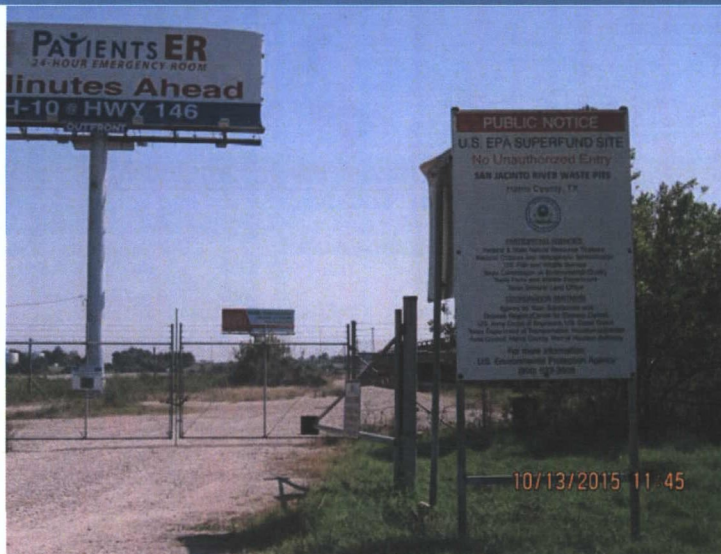
3) at the end of the TxDOT right-of-way north of I-10 near the San Jacinto River. For examples, see Photographs 1, 4, and 15 in Appendix A. These three signs were observed to be in place and undamaged.

Signage on all locked gates reminds entrants to "daisy chain" the locks properly prior to leaving the TCRA Site, as seen in Photograph 1. These signs were observed to be in place and undamaged.

Photograph 01: USEPA Public Notice Sign located outside access gate north of I-10 (view east)

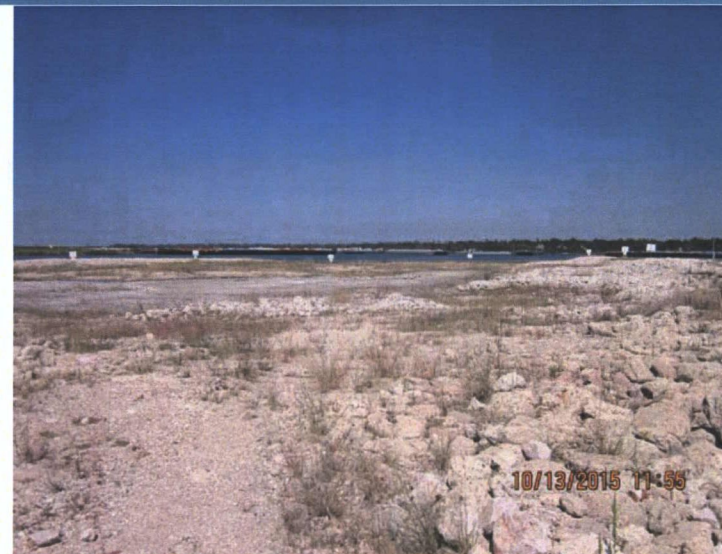
Photographs of the armored cap from the inspection event are provided in Appendix A (see Photographs 2 through 11). The majority of the Eastern Cell armored cap was underwater at the time of the initial inspection. All of the visible portions of the armored cap were observed to be intact, and no movement of cap materials was observed at any location. A subsequent visual inspection occurred on October 26, 2005 and is discussed below.

Photograph 02: Interior of Western Cell (view northwest)

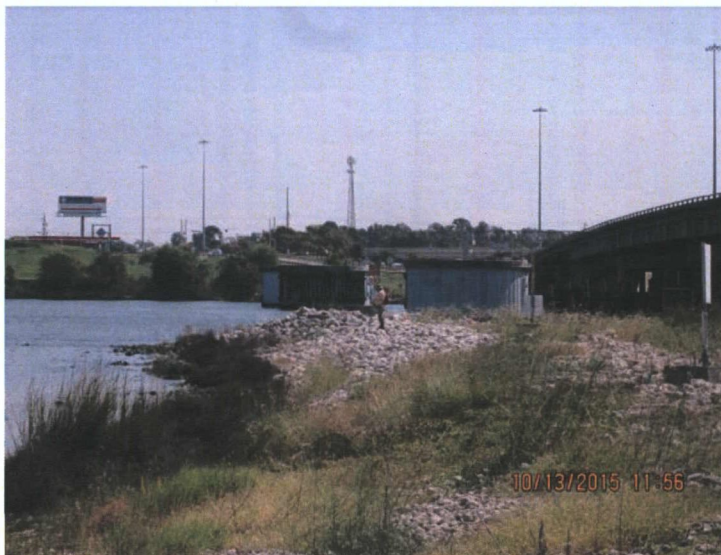
Photograph 03: Hydrographic Consultants performing topographic survey on southern berm (view east)

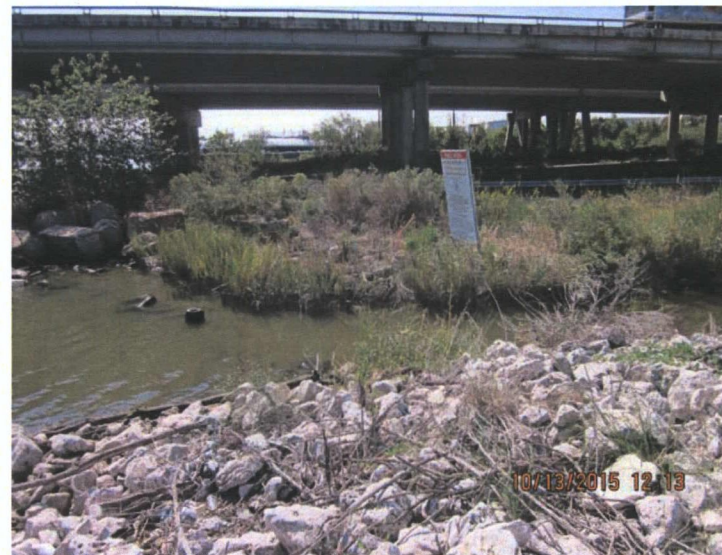
Photograph 04: USEPA Public Notice Sign located north of I-10 on west bank of San Jacinto River (view south)

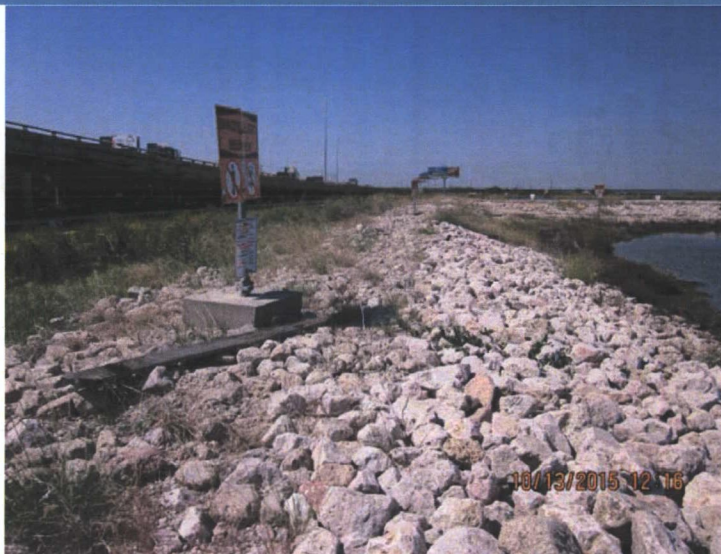
A total of fifteen signs were installed at the TCRA Site around the perimeter of the land portion of the TCRA Site; the signs are mounted on steel posts and set in concrete pads. For examples, see Photographs 5 through 8 in Appendix A. These signs are intended to face the San Jacinto River to deter water-based entry to the TCRA Site. A few of these signs had rotated out of proper alignment due to the wind, and the affected signs were re-aligned to the intended viewing perspective.

Photograph 05: Warning signs along southern berm (view west)

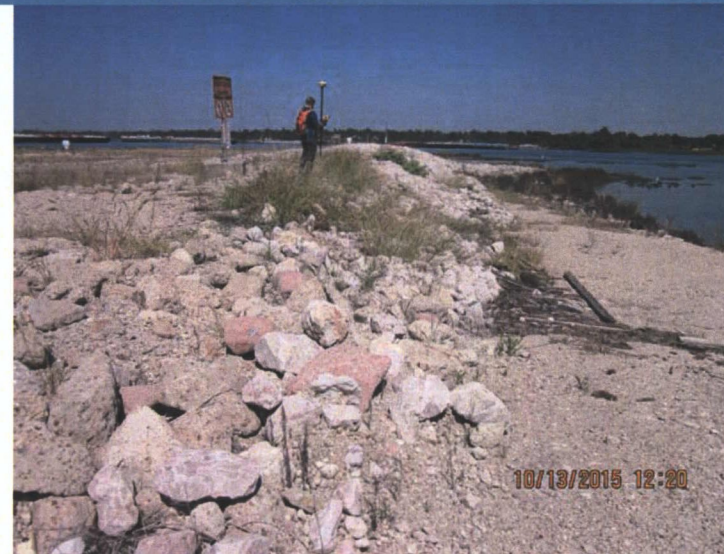
Photograph 06: Hydrographic Consultants performing topographic survey on central berm (view north)

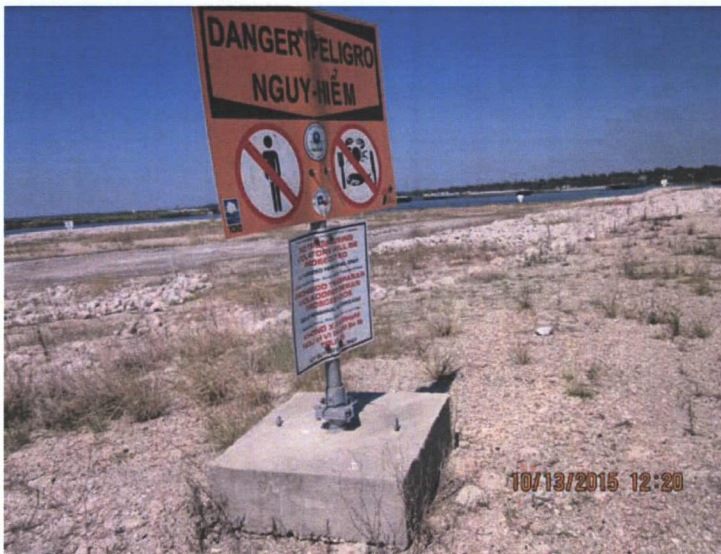
Photograph 07: Warning sign along central berm (view northwest)

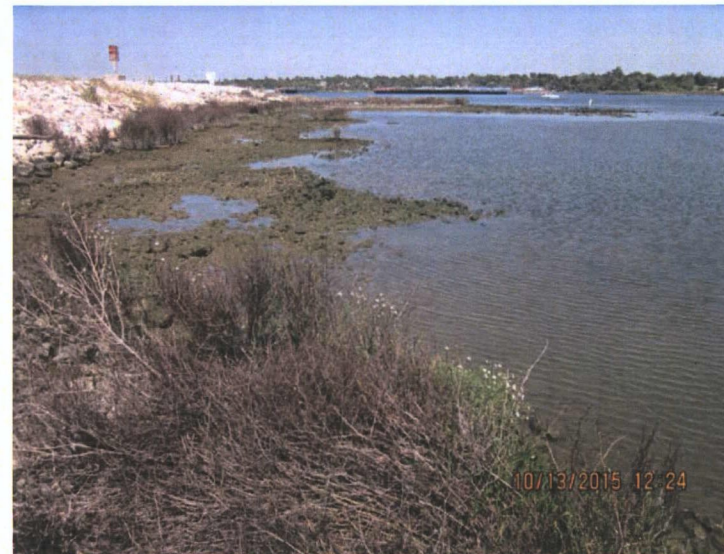
Photograph 08: Warning signs along western berm and Eastern Cell (view north)

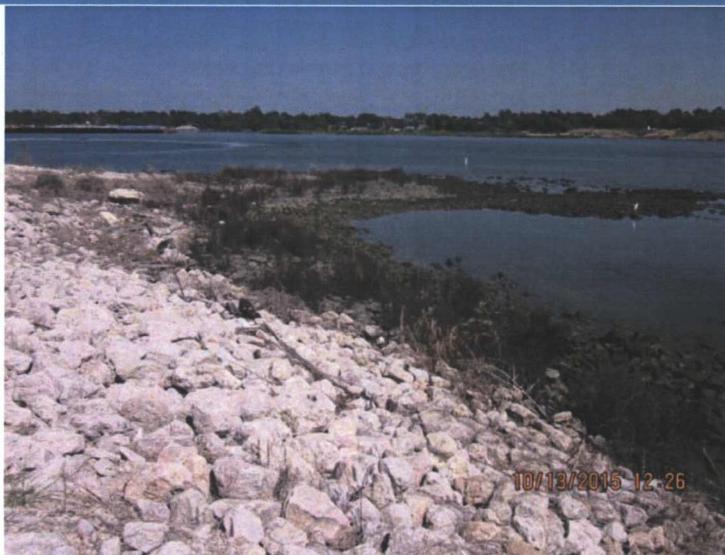
Photograph 09: Central berm and Eastern Cell (view northeast)

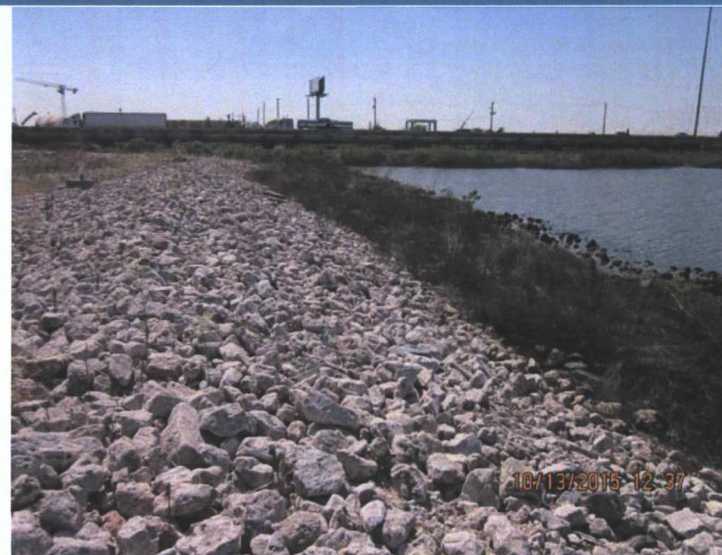
Photograph 10: Warning signs along western berm (view south)

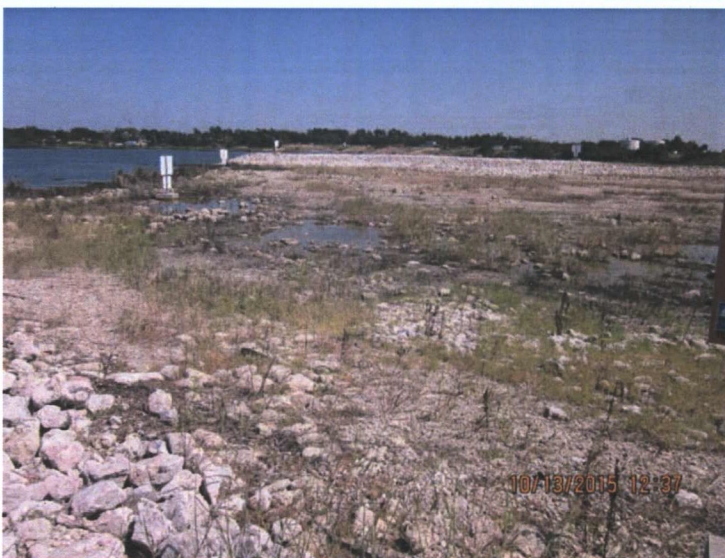
Photograph 11: Interior of Western Cell (view northeast)

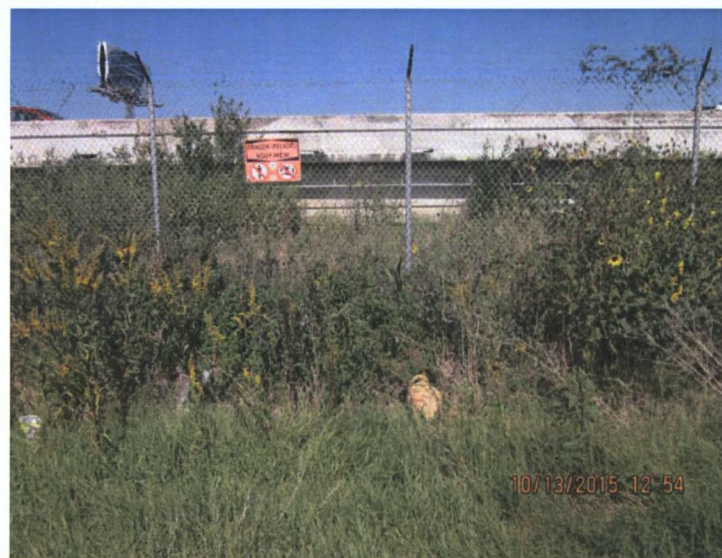
The perimeter fencing on the west and east banks of the San Jacinto River was visually inspected for breaches or other signs of damage. No breaches or other signs of fence damage were observed during the inspection for any of the three sections of the fence: the east bank, the west bank on the north side of I-10, or the west bank on the south side of I-10. For examples, see Photographs 12 and 14 through 16 in Appendix A.

"Danger" and "No Trespassing" signs are posted at regular intervals on the perimeter fencing surrounding the TCRA Site. For examples, see Photographs 12 and 14 in Appendix A. These signs were observed to be in place during the October 13, 2015 inspection.

Photograph 12: Signage and perimeter fencing south of I-10 on west bank (view north)

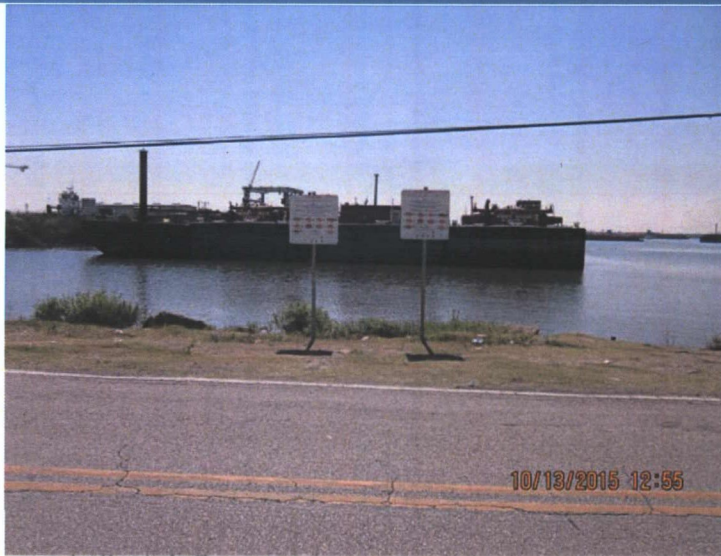
Photograph 13: Fish consumption advisory signs south of I-10 on west bank (view south)

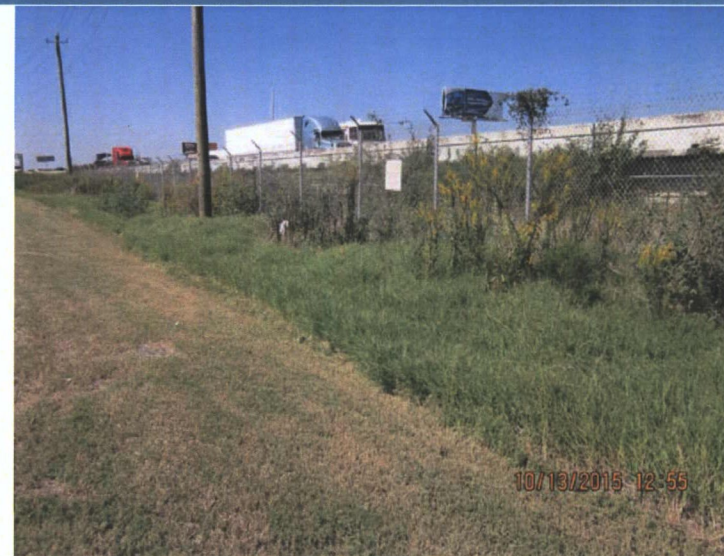
Photograph 14: Signage and perimeter fencing south of I-10 on west bank (view northwest)

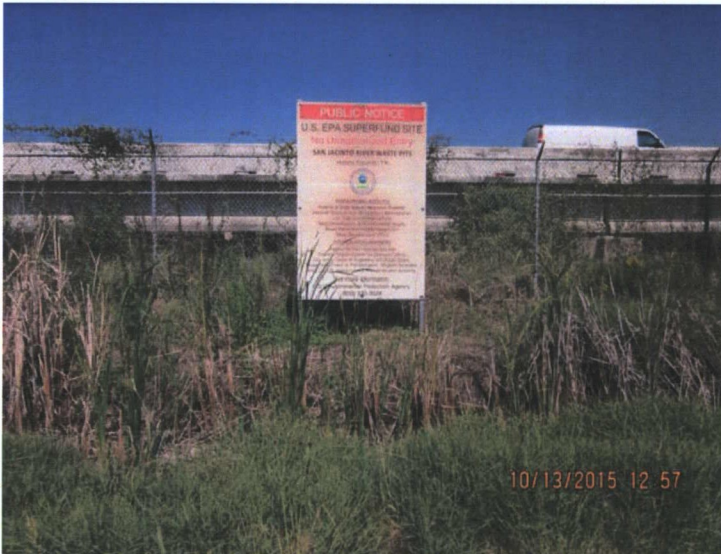
Photograph 15: USEPA Public Notice Sign south of I-10 on west bank (view north)

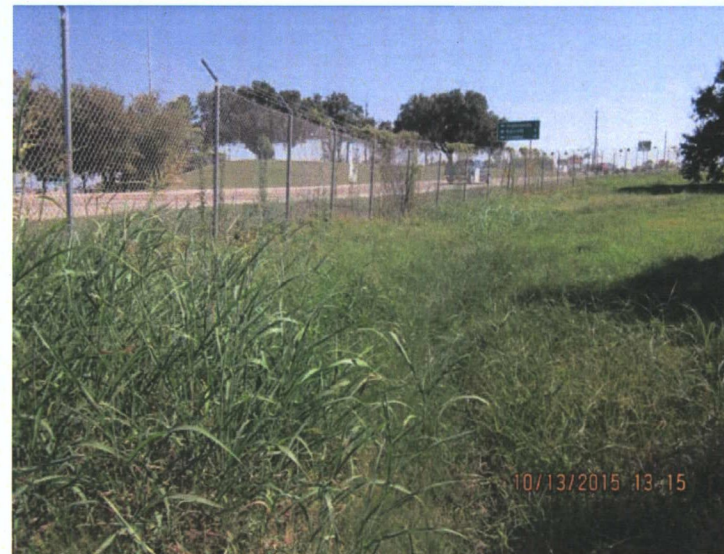
Photograph 16: Perimeter fencing south of I-10 on east bank (view northeast)

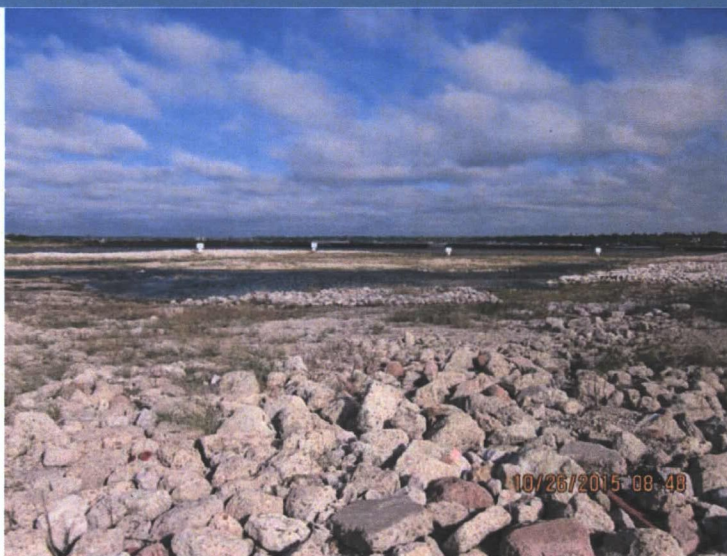
A voluntary visual inspection was performed on October 26, 2015 after two days of heavy rainfall. Nearly 8 inches of rain fell in the area on October 24 and 25, 2015, but the stage height at Lake Houston Dam stayed well below the 10-year flood level. The majority of the Eastern Cell was visible above the water level during the visual inspection. No movement of cap material was observed. See Photographs 17 through 20 for site conditions after the storm.

Photograph 17: Interior of Western Cell after heavy rainfall on October 24-25, 2015
(view northwest)

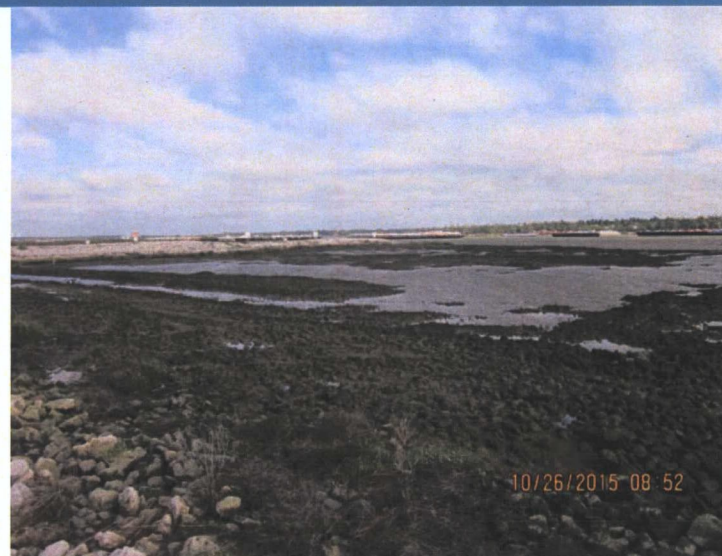
Photograph 18: Eastern Cell after heavy rainfall on October 24-25, 2015
(view northwest)

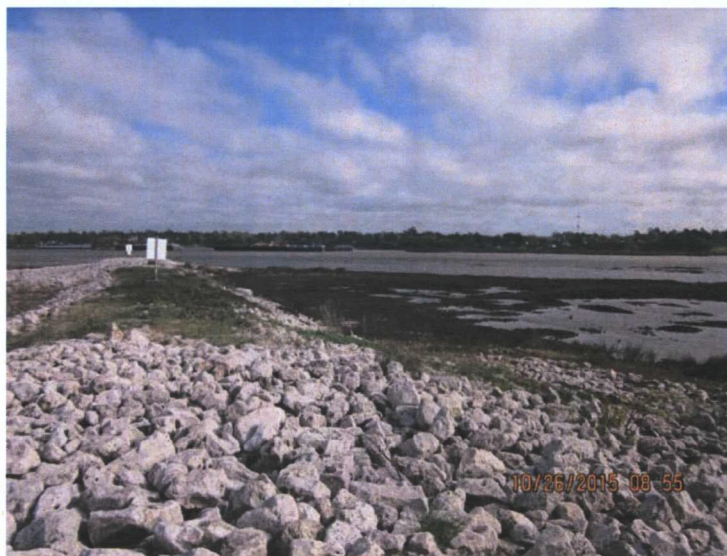
Photograph 19: Central berm after heavy rainfall on October 24-25, 2015
(view north)

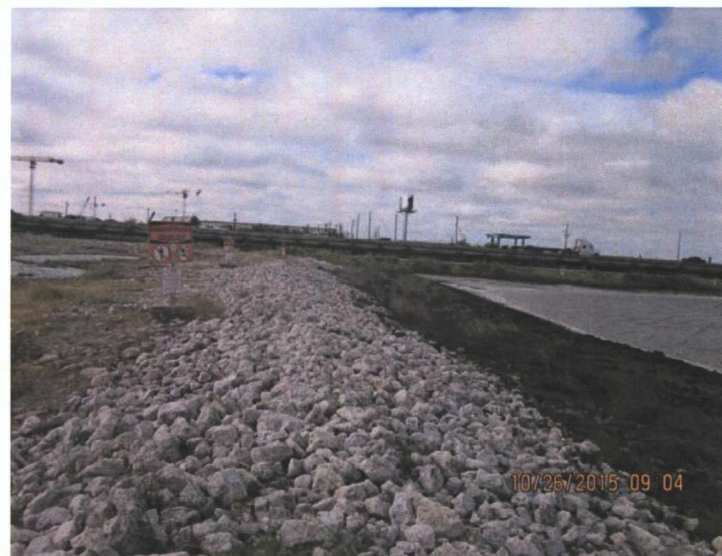
Photograph 20: Western berm after heavy rainfall on October 24-25, 2015
(view south)
